**Flood Control Project Maintenance
Levee Inspections**

Fall 2016 Levee Maintenance Deficiency Summary Report

Reclamation District No. 2094 Wathal

Levee Inspection Report By Mile - Fall 2016

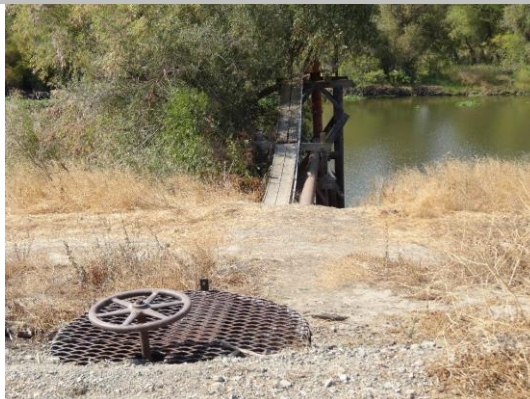
Photo 1 of 2 : UCIP_FA_2016_21464_36405.jpg

LM Start	0.65	Rating **	M	Issue No.	15
LM End	0.65	Issue Type +	En	Location *	WS
Category	Supplemental			GPS Latitude/Longitude	
				Start	End
Item	DWR UCIP Field Study			37.767514 °	37.767514 °
				-121.294926 °	-121.294926 °
DWR ID					
Comment Code					
Inspector Comment					
FS_ID:21464 DS_ID:23086 EP_NO: N/A Repair Type: Non-Urgent Crossing Status: Found UCIP Comments: - walkway in poor condition and needs repair.- electric conduit on waterside. FIELD_STRUCT_DESC: 14-inch concrete encased steel pipe and GI conduit through the levee, 10.0 feet below the crown, pump mounted on a pile structure in the stream, slide gate, 54-inch corrugated metal pipe riser on the waterward shoulder, concrete distribution box and service pole on the landward toe, installed by USCE, 1962 (O&M Unit No. 3, 1968) FS Date: 9/10/2013

WS view: gate valve in CMP riser (bottom) and pipe & pump (top) on piling structure in the channel.

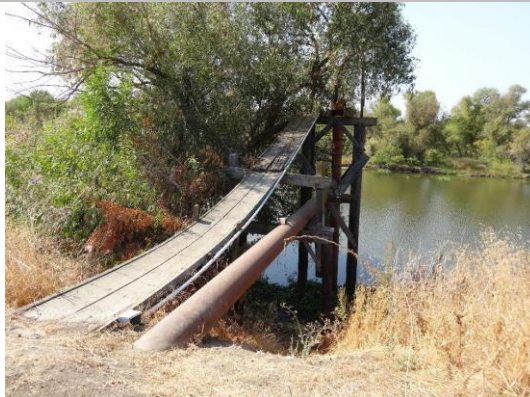
Photo 2 of 2 : UCIP_FA_2016_21464_36404.jpg

WS view: pump on piling structure in the channel. Pipe (right- bottom) and conduit (bottom- left).

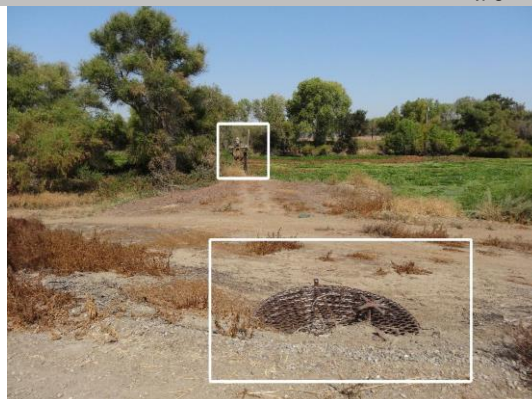
Photo 1 of 2 : UCIP_FA_2016_21544_36524.jpg

LM Start	1.25	Rating **	M	Issue No.	13
LM End	1.25	Issue Type +	En	Location *	WS
Category	Supplemental			GPS Latitude/Longitude	
				Start	End
Item	DWR UCIP Field Study			37.760581 °	37.760581 °
				-121.297373 °	-121.297373 °
DWR ID					
Comment Code					
Inspector Comment					
FS_ID:21544					
DS_ID:23087					
EP_NO: N/A					
Repair Type: Non-Urgent					
Crossing Status: Found					
UCIP Comments: - working as drainage system during field visit. Pump was not running.- electric conduit on WS- open pipe end in CMP riser. CMP needs cleaning.					
FIELD_STRUCT_DESC: 20-inch concrete encased steel pipe through the levee, 10.0 feet below the crown, pump mounted on a pile structure in the stream, gate valve, 54-inch corrugated metal pipe riser on the waterward shoulder, concrete distribution box and service pole on the landward toe (O&M Unit No. 3, 1968)					
FS Date: 9/10/2013

WS view: overview of pump (top) and CMP riser (bottom)

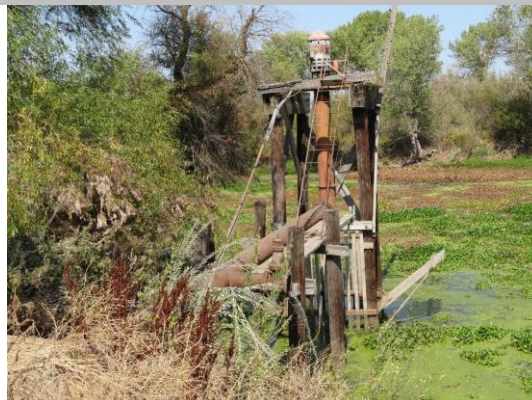
Photo 2 of 2 : UCIP_FA_2016_21544_36523.jpg

WS view: pipe and pump on piling structure in the channel. Walkway in poor condition.

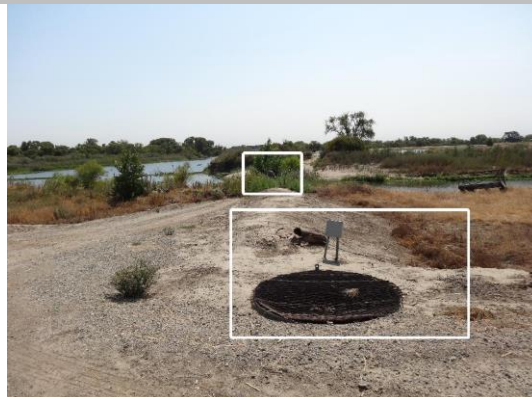
Photo 1 of 2 : UCIP_FA_2016_41726_36502.jpg

LM Start	2.25	Rating **	M	Issue No.	16
LM End	2.25	Issue Type +	En	Location *	WS
Category	Supplemental			GPS Latitude/Longitude	
				Start	End
Item	DWR UCIP Field Study			37.752230 °	37.752230 °
				-121.296408 °	-121.296408 °
DWR ID					
Comment Code					
Inspector Comment					
FS_ID:41726					
DS_ID:23088					
EP_NO: N/A					
Repair Type: Non-Urgent					
Crossing Status: Found					
UCIP Comments: - dense vegetation on WS.- working during field survey.- slide gate not found on WS.					
FIELD_STRUCT_DESC: 20-inch concrete encased steel pipe through the levee, 6.0 feet below the crown, slant pump mounted on a frame structure on the stream bank, 54-inch corrugated metal pipe riser on the waterward shoulder, concrete distribution box and service pole on the landward toe (O&M Unit No. 3, 1968)					
FS Date: 9/10/2013

WS view: slant pump (top) on stream bank and CMP riser on levee shoulder.

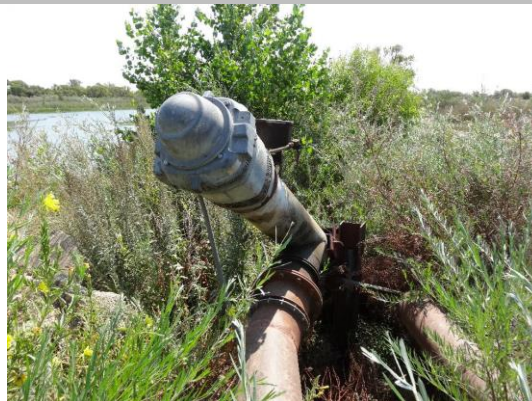
Photo 2 of 2 : UCIP_FA_2016_41726_36501.jpg

WS view: slant pump on stream bank and dense vegetation on stream bank.

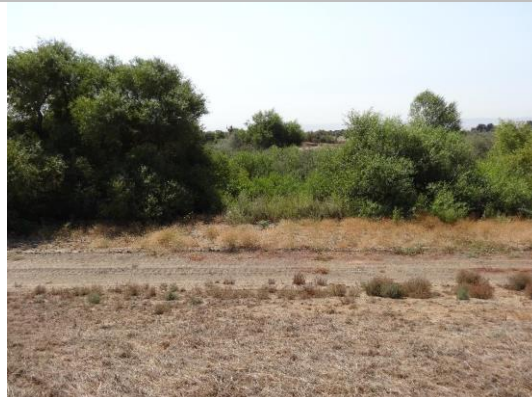
Photo 1 of 2 : UCIP_FA_2016_21545_36529.jpg

LM Start	2.45	Rating **	M	Issue No.	14
LM End	2.45	Issue Type +	En	Location *	WS
Category	Supplemental			GPS Latitude/Longitude	
				Start	End
Item	DWR UCIP Field Study			37.752308 °	37.752308 °
				-121.293191 °	-121.293191 °
DWR ID					
Comment Code					
Inspector Comment					
FS_ID:21545 DS_ID:23089 EP_NO: N/A Repair Type: Non-Urgent Crossing Status: Found UCIP Comments: - no pipes found on either side of the levee.- concrete distribution box on LS. Soil erosion around distrinution box. FIELD_STRUCT_DESC: Rectangular concrete distribution box on the landward toe FS Date: 9/10/2013

WS view: no pipe found on waterside.

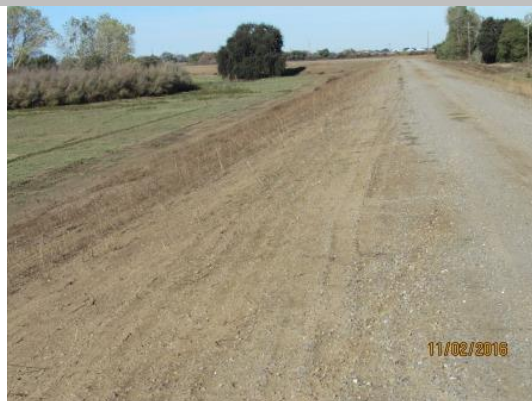
Photo 1 of 1 : FA_2016_RD2094_321_1_20161104_00001.jpg

LM Start	0.02	Rating **	A	Issue No.	1
LM End	0.43	Issue Type +	Ma	Location *	WS
Category	Earthen Levee			GPS Latitude/Longitude	
				Start	End
Item	Vegetation			37.759323 °	37.760606 °
				-121.299904 °	-121.306989 °
DWR ID	DWR_RD2094_02_f_2016_1				
Comment Code					
V1 : Control annual grass and weeds on the levee slopes and easements.					
Inspector Comment					
LMA has good vegetation control program.

View of the vegetation on the waterside levee slope.
